Accident No. 43-5-11-64

WAR DEPARTMENT
MacDill Field, Florida
U. S. ARMY AIR FORCES
REPORT OF AIRCRAFT ACCIDENT

(1) Place MacDill Field, Florida (2) Date May 11, 1943 (3) Time 2146 EWT
AIRCRAFT: (4) Type and model B-26C (5) A. F. No. 41-24757 (6) Station MacDill Field, Florida
Organization: (7) III BC: 3 AF (8) 391st Bomb Gr (9) 572nd Bomb Sq (10) 1st Lt.
(Command and Air Force) (Group) (Squadron) (Rank)

(46) Weather at the time of accident Contact - see weather report.
(47) Was the pilot flying on instruments at the time of accident No
(48) Cleared from MacDill (49) To MacDill (50) Kind of clearance Local
(51) Pilot's mission Night navigation.
(52) Nature of accident Landing accident.
(53) Cause of accident Right main landing gear collapsed.
AIRCRAFT - CG 23 SC 67 UC 34

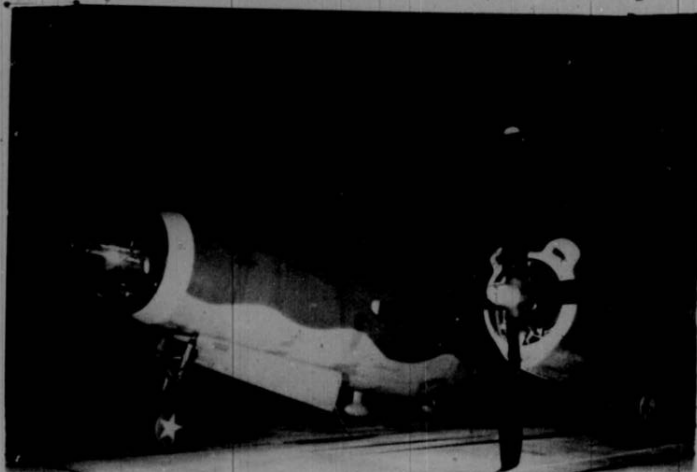
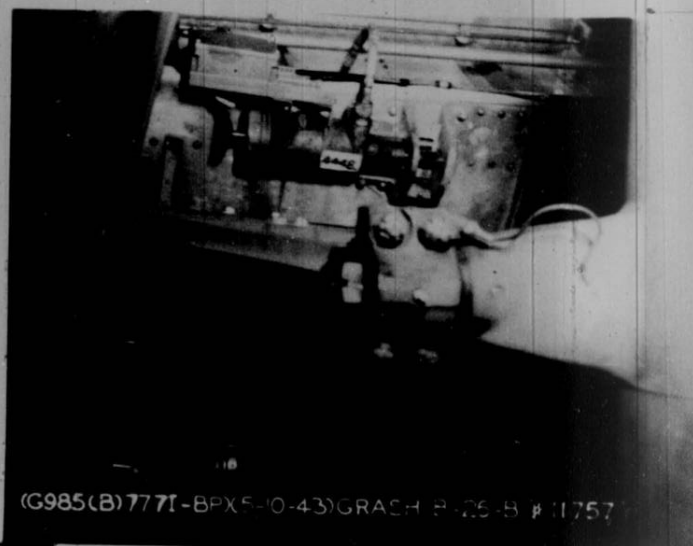
(G985(B) 777I-BPX5-10-43) GRASH P-25-B # 11757

1. The following parts were damaged on B-26C airplane #41-34757 due to collapse of main landing gear:

- a. Left and right propellers, all blades damaged beyond repair.
- b. Sudden stoppage of propeller, left engine.
- c. Part of skin ground off and buckles on bottom of fuselage, from station no. 434 1/4 to station no. 624 7/8.
- d. Formers partly ground off, or vent on bottom of fuselage, from station no. 447 1/4 to station no. 624 7/8.
- e. Two antenna masts broken off, right side of tail section of fuselage.
- f. Tail bumper assembly damaged beyond repair.
- g. Right and left camera doors damaged beyond repair.
