ACCIDENT No. 188

WAR DEPARTMENT
Godman Field, Fort Knox, Kentucky
U. S. ARMY AIR FORCES
REPORT OF AIRCRAFT ACCIDENT

(1) Place Six (6) Miles S.W. Godman Field, Ky. (2) Date 25 September 1943 (3) Time 1200-CWT.
AIRCRAFT: (4) Type and model L-38 (5) A. F. No. 42-36126 (6) Station Godman, 412th Sub-Depot
Organization: (7) Air Service Command 412th Sub-Depot

SUBJECT: Extent of damage to Wrecked Airplane

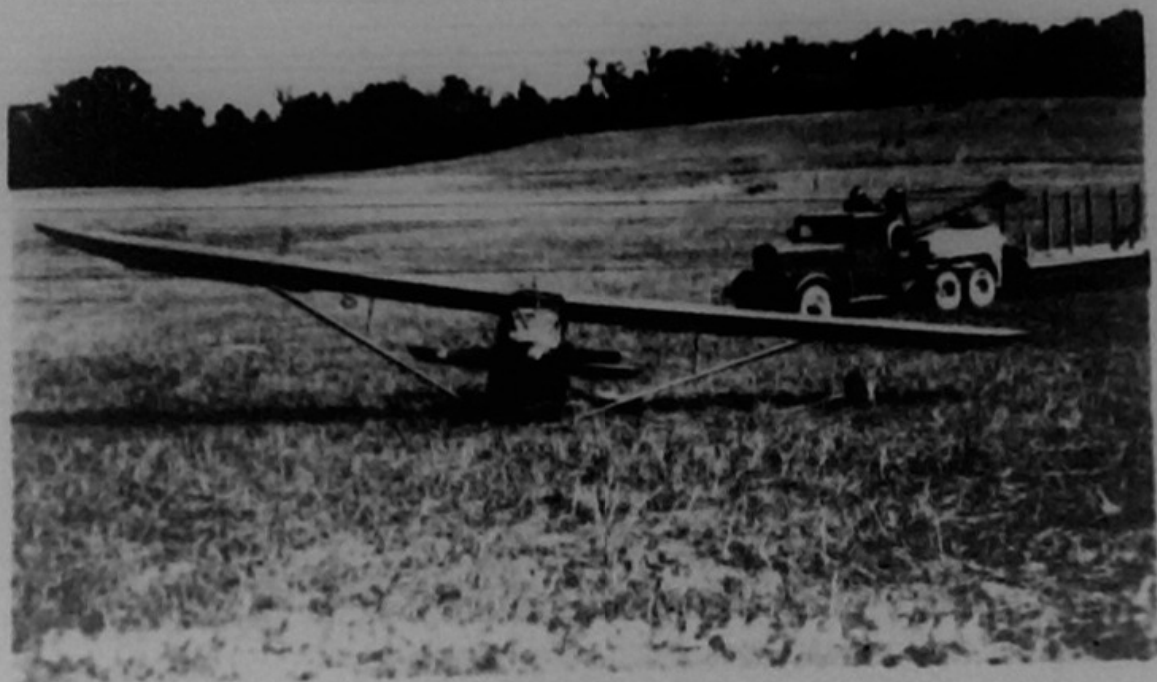
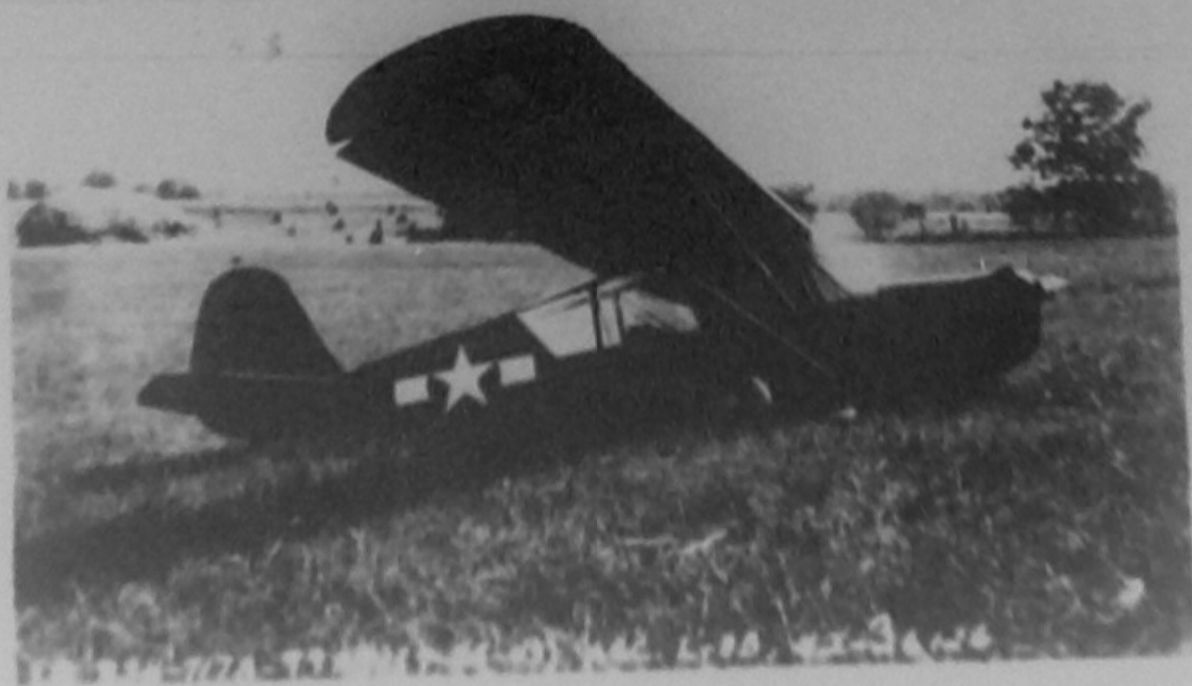
The switches and gas were cut. The landing was a very rough three point landing on rough terrain. The landing gear collapsed and twisted the right wing, both of which will have to be replaced.

The impact was too much for the gear, which gave way, causing the plane to rock forward on its nose and then to settle back on its belly-the tail down-hill.
