REPORT OF AIRCRAFT ACCIDENT

23 March 1944

B-26B48MA V-100 42-98816

SUBJECT: Accident Report on B-26B45 Airplane No. 42-95816.

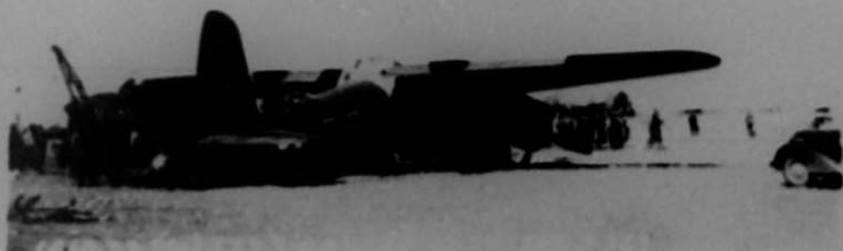
1. Overall showing break between bomb bay and collapsed main wheel.

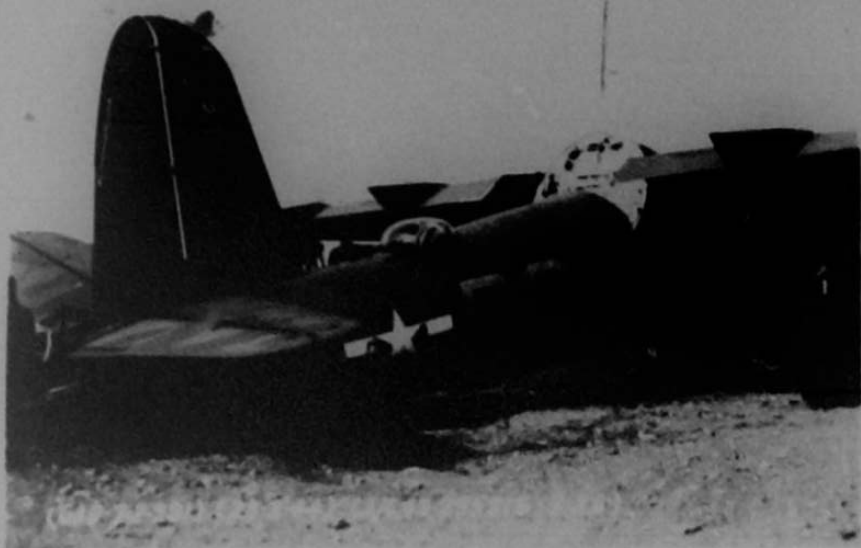
a. Upon impact of landing, approximately 150 yards short of runway proper, the fuselage began separating at station 346 $\frac{1}{2}$, beginning from the upper part and coming around the girth to the main girder, which was the only member keeping both sections of the fuselage together. The rear section was dragged across the dirt and down the runway, where the airplane swerved to the left and went off the runway. There, the nose wheel struck a man hole and proceeded a few more feet across this man hole before coming to a stop. The following damage was caused under Category "a"

2. Break at bulkhead between forward and rear bomb bay (station 346). Note rear bomb bay door still in ditch. The ditch is discernable directly under the tail assembly.
