HEADQUARTERS
AAF STATION A-73.

SUBJECT: Report of Aircraft Accident, A.F. No. 44-67840.

REPORT OF AIRCRAFT ACCIDENT

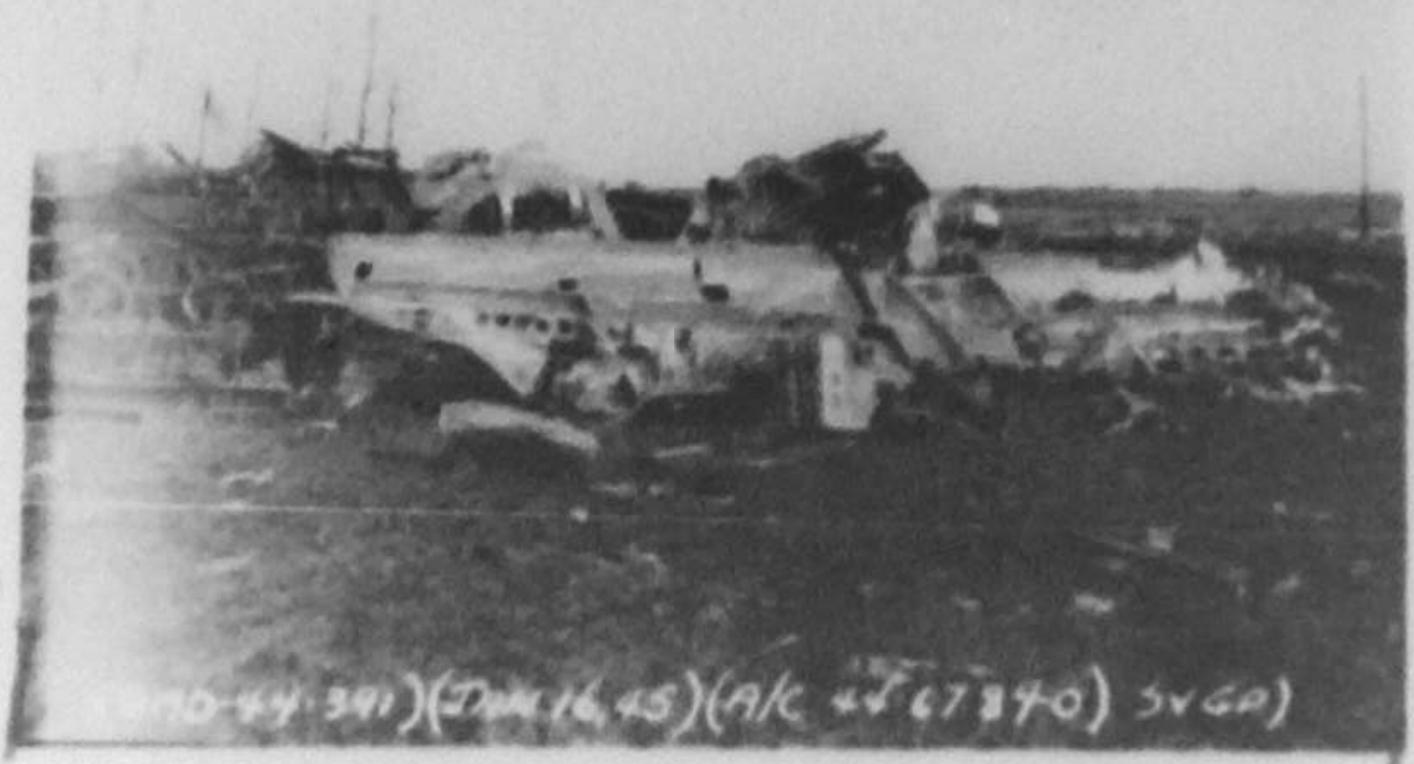
SD-44-341) (Dak 16.45) (A/C 4567370) 5v GP)

Plane crashed into ground immediately after take-off.

Inspection of the two engine assemblies showed that the left and right engine propellers had lost three and two blades respectively, the complete blade in each case having been torn in its entirety from the propeller hub.

The board feels that this accident was the result of either complete or partial failure of the left engine immediately after take-off.
